MINE LAKE DAM
(Inventory Number NY 767)
ORANGE COUNTY,
NEW YORK.

INVENTORY NO NY 767

PHASE I INSPECTION REPORT,
NATIONAL DAM SAFETY PROGRAM

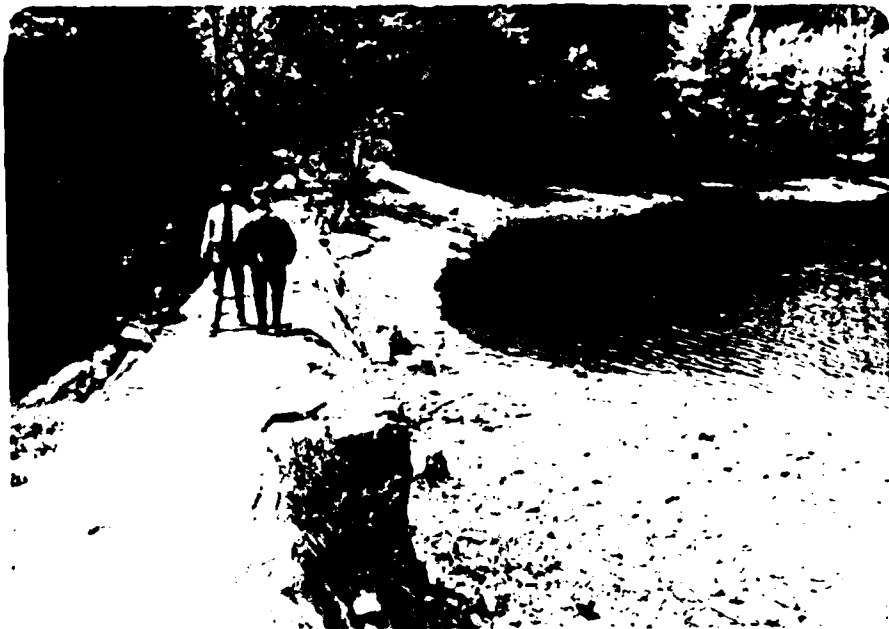
1. Close-up view across spillway section with reservoir in drawn down condition.

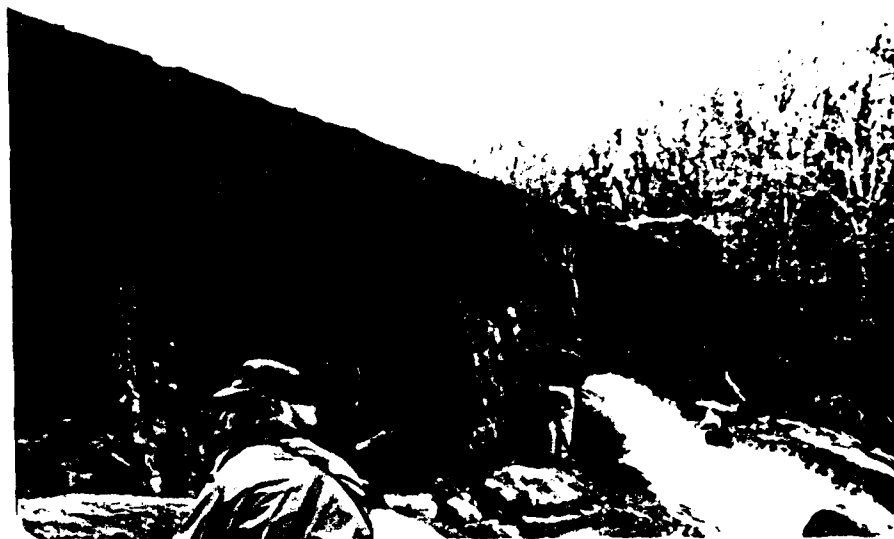
5. View across downstream face of spillway area.

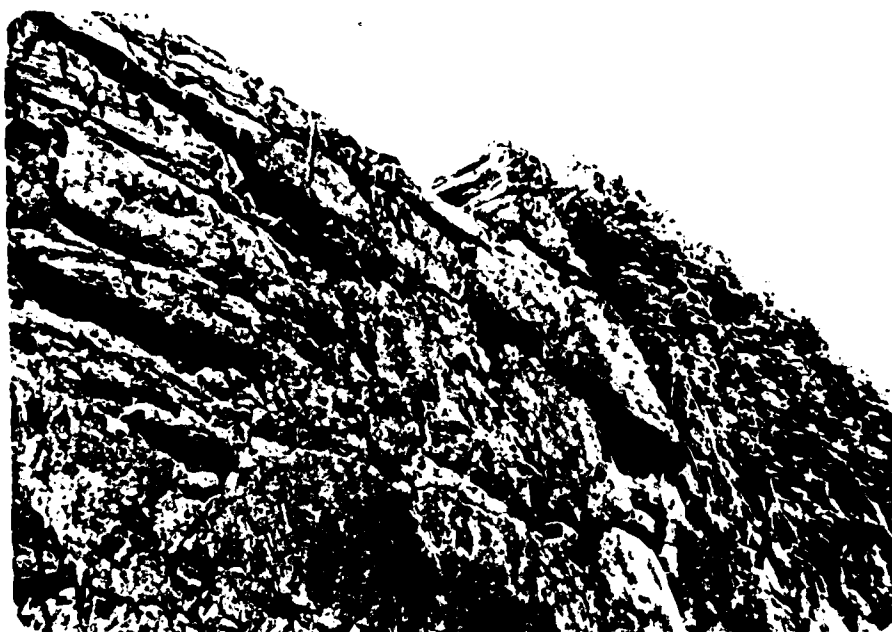
8. Close-up of spillway wall area.

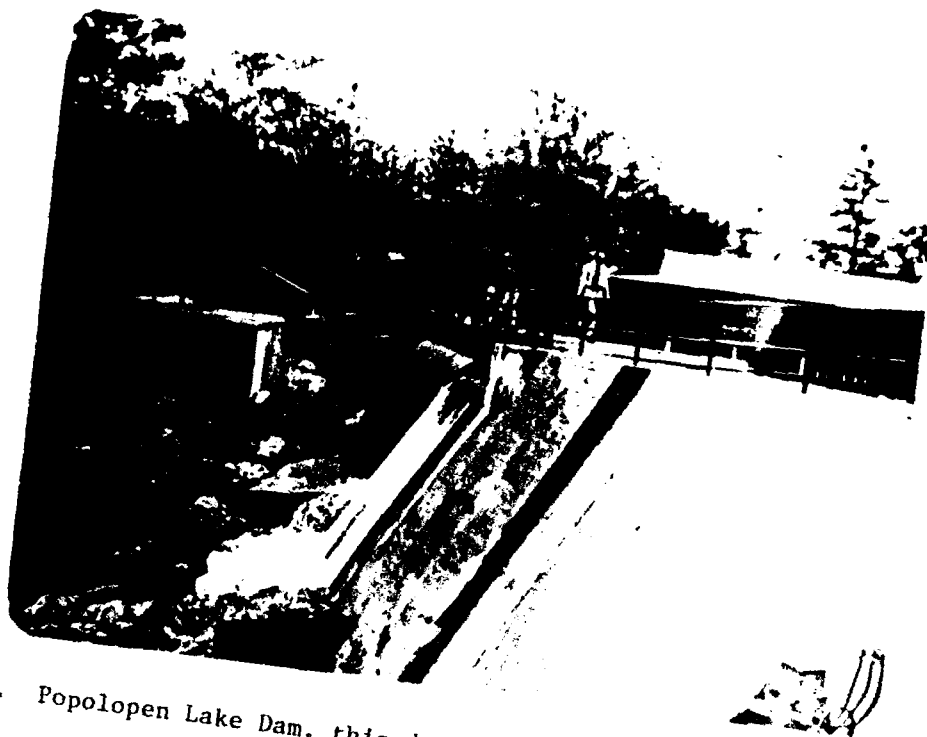
11. Popolopen Lake Dam, this dam is upstream of Mine Lake Dam.

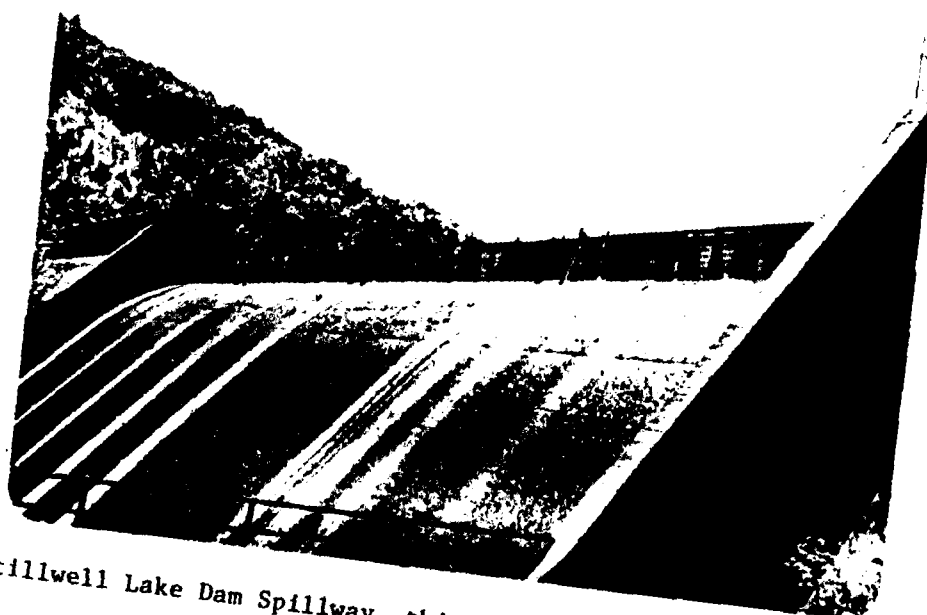
12. Stillwell Lake Dam Spillway, this dam is downstream of Mine Lake Dam.

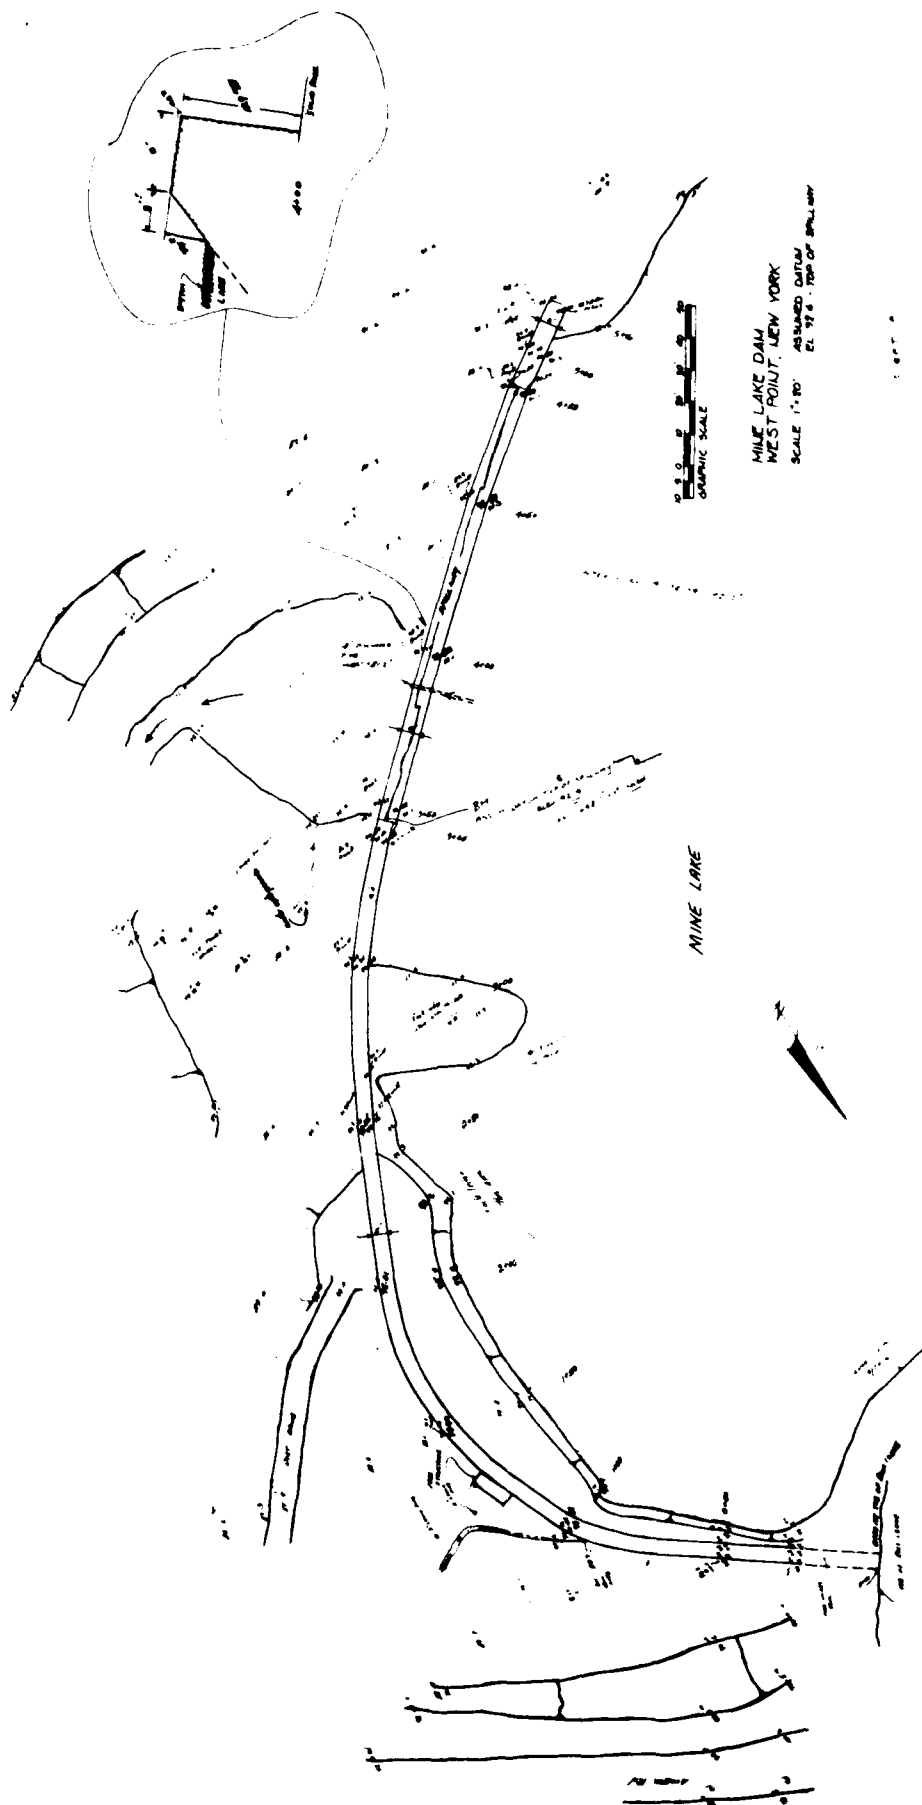
FIGURE 2

The spillway is a broad crested weir 143 feet long. The vertical alignment of the spillway is fairly irregular and is shown in detail in Figure 2. Figure 3, an elevation view of the masonry in the spillway area, shows the location of the leakage through the dam. The spillway crest is formed in concrete and is deteriorated in various points along the length of the spillway. The width of the spillway crest is approximately 6 feet.
